Building Description

Attribute	Description / Type	Address / Comments
Age (approximate)	1986	xxxxxxxxxxxxxxxxxxxxxxxxxxxx
Area (approximate)	1320 + 604 Garage + porches	xxxx Jean St
Building type	<input checked="" type="checkbox"/> Single Family	Cocoa, FL
	<input type="checkbox"/> Duplex / Twinplex	
	<input type="checkbox"/> Condominium	
	<input type="checkbox"/> Other - see comments	
Construction	<input checked="" type="checkbox"/> Frame	
	<input type="checkbox"/> Brick	
	<input type="checkbox"/> Block	
	<input type="checkbox"/> Other - see comments

Job: xxxx Jean St

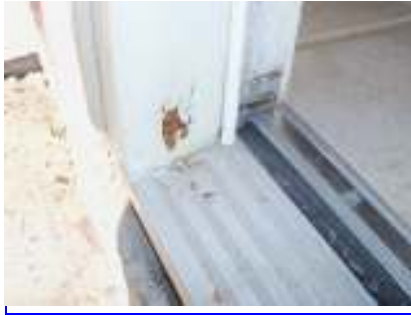
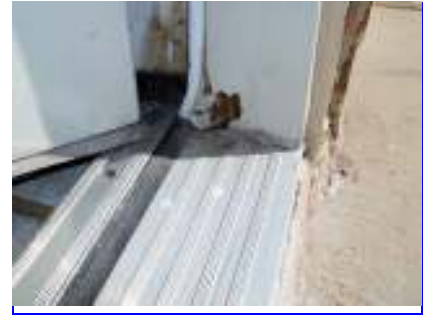
Front door has wood rot on lower 6 inches of both sides of door jamb. Recommend replace bottom of jambs

Front door wood rot in jamb

5. Front door has wood rot on lower 6 inches of both sides of door jamb. Recommend replace bottom of jambs \$100
6. Fascia on east side gable has large dent and fold. Not sure as to cause. Recommend remove and inspect for truss damage

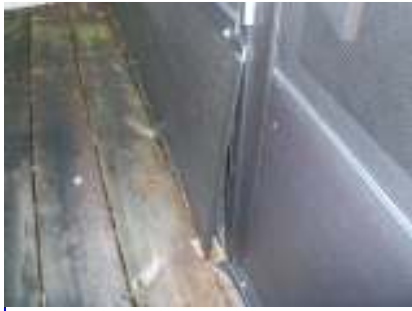
Comments
Slope away from house	<input checked="" type="checkbox"/>	
Driveway	<input checked="" type="checkbox"/>	Concrete
Porch	<input checked="" type="checkbox"/>	Concrete
Patio / deck	<input checked="" type="checkbox"/>	Concrete base, wood deck over concrete
Deck	<input checked="" type="checkbox"/>	Wood deck partially around pool
	<input type="checkbox"/>	
Additional comments:		
Panel is loose and bent on kickplate on rear porch next to screen door. Recommend reattach

Screen room kickplate loose

1. Panel is loose and bent on kickplate on rear porch next to screen door. Recommend reattach \$10
2. Chimney needs caulked and painted. Chimney cap loose and needs painted \$100

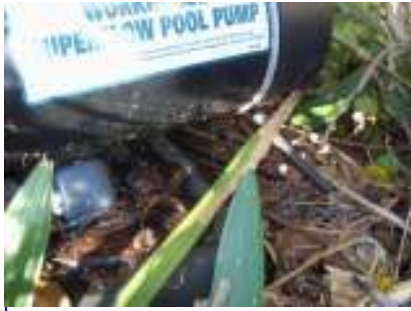
Filter		Comments	Pumps		Comments
<input checked="" type="checkbox"/>	Filter	Filter is clogged	<input checked="" type="checkbox"/>	Circulation pump	Pump leaks and will not turn on. Recommend replace pump
<input type="checkbox"/>	Housing		<input type="checkbox"/>	Attachment	
<input type="checkbox"/>	Fittings		<input type="checkbox"/>	Sweep pump	
<input type="checkbox"/>	Pressure gauge		<input type="checkbox"/>	Attachment	
<input type="checkbox"/>	Bleeder valve		<input type="checkbox"/>	Jet pump	
<input type="checkbox"/>	Supply line		<input type="checkbox"/>	Attachment	
<input type="checkbox"/>	Discharge line		<input type="checkbox"/>	Auxiliary pump	
<input type="checkbox"/>	Pressure switch		<input type="checkbox"/>	Water feature pump

Pool pump leaking and not working

21. Ceiling fan in purple bedroom is loose and not installed properly. Recommend correct installation. \$100
22. Pool pump leaks and will not turn on. Recommend replace pump \$300-400

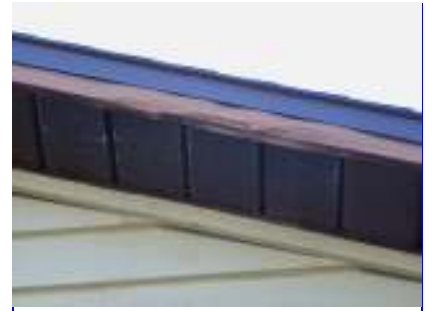
Fascia on east side gable has large dent and fold. Not sure as to cause. Recommend remove and inspect for truss damage

Crumpled fascia on East side

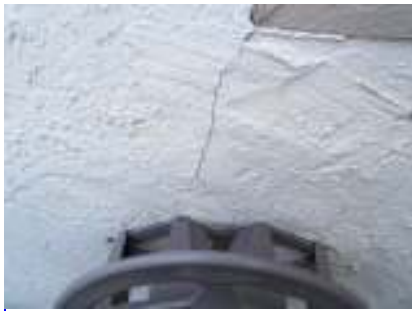
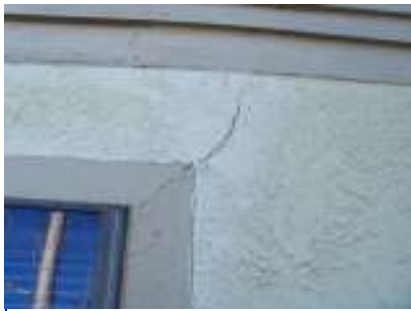
Stucco has large settlement crack on East side next to window. Recommend seal crack, stucco patch, and paint

East side large settlement cracking

3. Gutters are full of debris and do not drain properly. Recommend clean out and seal joints and corners \$50
4. Stucco has large settlement crack on East side next to window. Recommend seal crack, stucco patch, and paint \$100

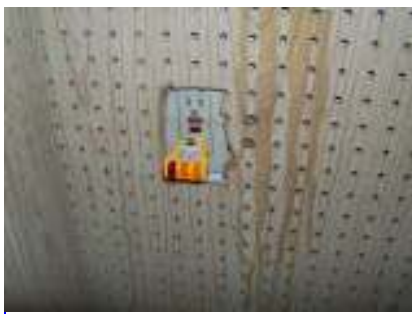
GFCI plug and circuit is not functioning as designed. Recommend replace GFCI plug

Garage GFCI malfunctioning

7. Rear french door is missing bottom slide lock on stationary door, doors will not lock properly. Recommend replace lock. \$50
8. GFCI plug and circuit is not functioning as designed. Recommend replace GFCI plug \$50

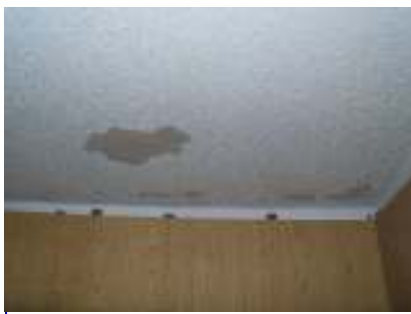
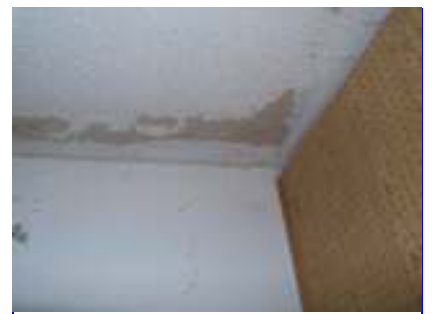
Garage ceiling has several area of missing popcorn texture. No sign of water leak/damage. Common occurrence due to humidity.

Texture missing in garage

9. Garage ceiling has several area of missing popcorn texture. No sign of water leak/damage. Common occurrence due to humidity.
10. Fireplace screen is broken and off track. Recommend replace screen \$75

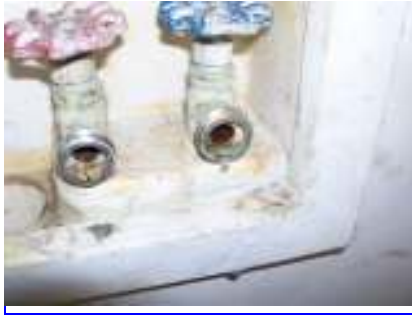
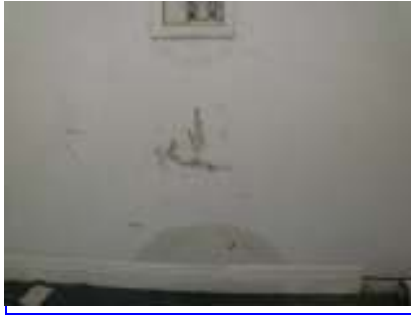
All sinks in house are plugged and filled with water. The water is left standing for duration of inspection and then sink is emptied and checked for leaks.
Washer connection valves are both actively leaking and have caused damage to surround wall and baseboard. Recommend replace both valves and drywall to prevent mold.
Note: RED check boxes , when checked, indicate that attention is needed. Failure to attend to these items may result in damage or create a safety hazard.

Washer valve actively leaking

Water damage to wall in laundry

11. Left rear burner of stove is not working. Recommend replace element. \$50
12. Washer connection valves are both actively leaking and have caused damage to surround wall and baseboard. Recommend replace both valves and drywall to prevent mold. \$200

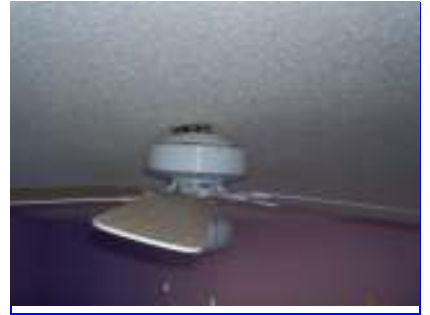
Ceiling fan in purple bedroom is loose and not installed properly. Recommend correct installation.

Ceiling fan loose

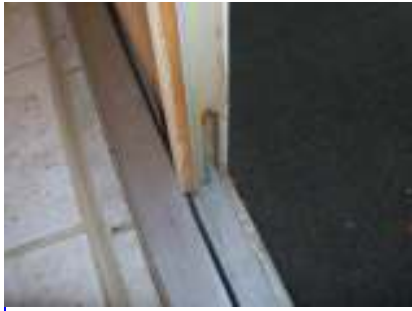
Rear french door is missing bottom slide lock on stationary door, doors will not lock properly. Recommend replace lock

French door slide lock missing

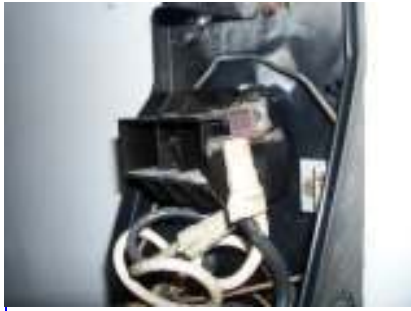
<u>Air Handler electrical disconnect is broken and bypassed. Recommend installing new disconnect.</u>
<u>Note: RED check boxes, when checked, indicate that attention is needed. Failure to attend to these items may result in damage or create a safety hazard.</u>

Air handler disconnect broken

19. Air Handler electrical disconnect is broken and bypassed. Recommend installing new disconnect. \$150
20. All detectors are broken. Recommend replace all detectors. \$75

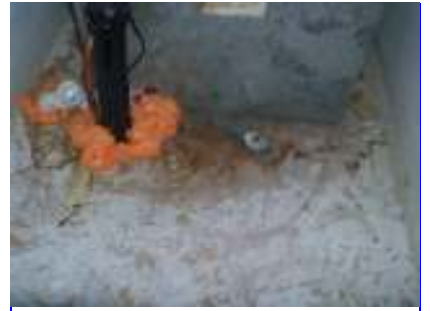
Previous water damage on base

17. Air handler base shows signs of previous water damage from water backup. Recommend monitor due heavy use.
18. Air handler is missing filter. Recommend replace filter \$15

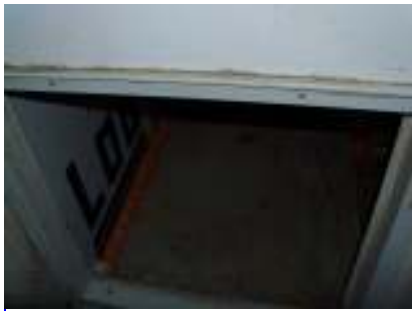
Item / Attribute	Type / Description	Condition	Comments
Cooling source	<input checked="" type="checkbox"/> Whole House Forced Air	<input checked="" type="checkbox"/> Good	
	<input type="checkbox"/> Window	<input type="checkbox"/> Fair	
	<input type="checkbox"/> Other	<input type="checkbox"/> Marginal	
	<input type="checkbox"/> See comments	<input type="checkbox"/> Poor	
		<input type="checkbox"/> Unable to test	
Distribution	<input type="checkbox"/> Sheet Metal	<input checked="" type="checkbox"/> Good	Temp Differential: 21.6 F Excellent
	<input checked="" type="checkbox"/> Flex Duct	<input type="checkbox"/> Fair	
	<input type="checkbox"/> Zoned	<input type="checkbox"/> Marginal	
	<input checked="" type="checkbox"/> Rigid Fiberboard	<input type="checkbox"/> Poor	
Comments:			
<u>Air handler base shows signs of previous water damage from water backup. Recommend monitor due heavy use.</u>			
<u>Air handler is missing filter. Recommend replace filter</u>

Air handler missing filter

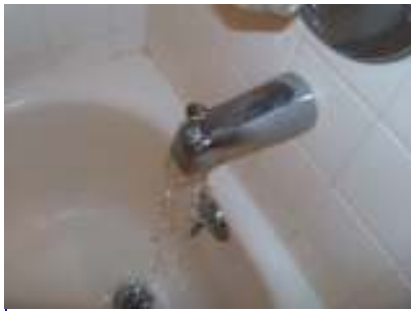
Master faucet "stuck" on shower

15. Master bath-tub spout shower diverter knob is stuck and shower is always on. Recommend replace tub spout \$50
16. Guest bath-tub faucet is leaking severely from handle when turned on. Recommend replace internal stem if available. \$100

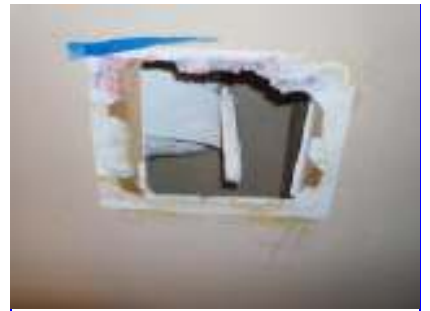
Missing toilet paper holder

13. GFCI plugs in both bathrooms are not functioning as designed. Recommend replace GFCI plugs \$100
14. Master bath-Large hole in wall next to toilet from missing paper holder. Recommend patch or replace with new. \$50

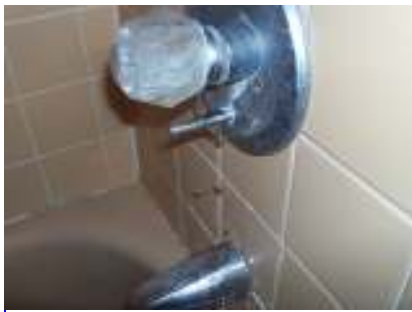
Hall bath faucet handle leaking

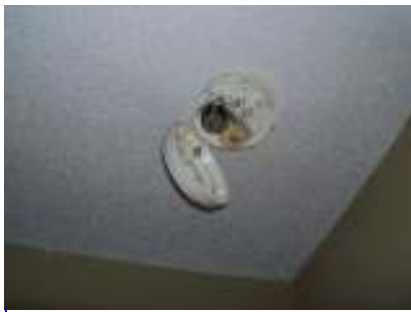
<input type="checkbox"/> See comments	<input type="checkbox"/> Poor	
Smoke Detectors	<input checked="" type="checkbox"/> Bedrooms/Vicinity	<input type="checkbox"/> Good	All detectors are broken.
	<input checked="" type="checkbox"/> Kitchen	<input type="checkbox"/> Fair	Recommend replace all detectors
	<input type="checkbox"/> Garage	<input type="checkbox"/> Loose	
		<input checked="" type="checkbox"/> Broken	
Ground	<input checked="" type="checkbox"/> Water line	<input checked="" type="checkbox"/> Good	
	<input checked="" type="checkbox"/> Ground rod	<input type="checkbox"/> Fair	
	<input type="checkbox"/> See comments	<input type="checkbox"/> Loose	
		<input type="checkbox"/> Needs repair	
GFCI Breakers/ AFCI Breakers	<input type="checkbox"/> Bath/Kitchen/Exterior	<input type="checkbox"/> Tested	
	<input type="checkbox"/> Bedrooms	<input type="checkbox"/> Not tested

All smoke detectors are broken

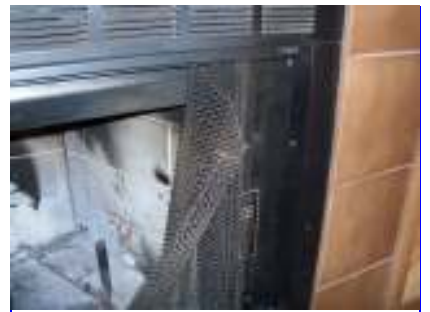
Fireplace	<input type="checkbox"/> masonry, brick	<input checked="" type="checkbox"/> Good / Fair	Fireplace screen is broken and off track.
	<input checked="" type="checkbox"/> Wood burner	<input type="checkbox"/> Need to clean	
	<input type="checkbox"/> None	<input type="checkbox"/> Cracks	Recommend replace screen
	<input type="checkbox"/> Other / see comments	<input checked="" type="checkbox"/> Repair needed

Broken fireplace screen
